MISCELLANEOUS PAPER S-72-22

CONDITION SURVEY, FORNEY ARMY AIRFIELD FORT LEONARD WOOD, MISSOURI

June 1972

Conducted by U. S. Army Engineer Waterways Experiment Station
Soils and Pavements Laboratory
Vicksburg, Mississippi

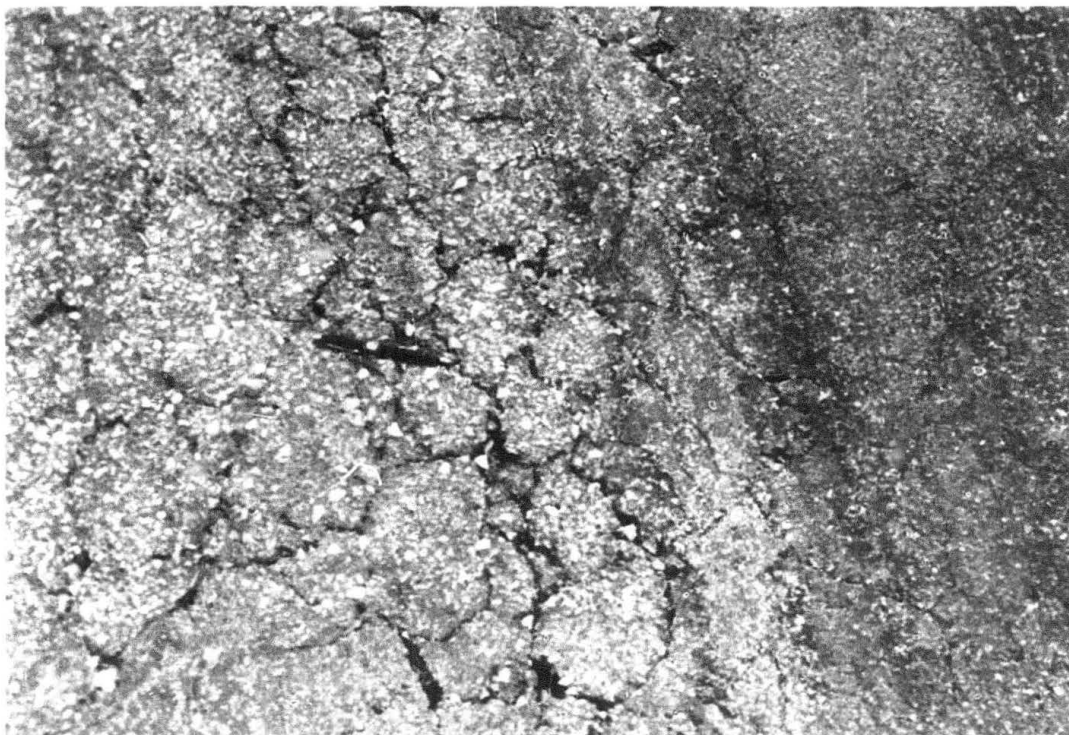
8. A visual inspection of the pavements in April 1971 indicated the airfield pavement to be generally in fair condition. The runway contained numerous cracks; however, the major portion appeared to be adequately supporting the aircraft using the pavement. The typical condition of the major portion of the runway pavement is shown in photograph 1. Photograph 2 shows the condition of an area about 25 ft wide, located east of the center line and extending from the vicinity of runway sta 34+60 to 40+60; this area is showing considerable distress. Another area, approximately 25 by 100 ft and located near runway sta 65+00, showed some distress

11. An evaluation of the pavements based on this visual inspection cannot be made without supporting field tests. The Facilities Engineer has requested the Omaha District, Corps of Engineers, to prepare an estimate for the performance of field testing and for an evaluation of the pavement facilities. Due to the fact that one area of the runway is showing considerable distress and another area shows distress to a lesser degree, it must be assumed that the load-carrying capacity of the runway pavement structure has been or is being exceeded.

Photograph 2. Distressed area near middle of runway

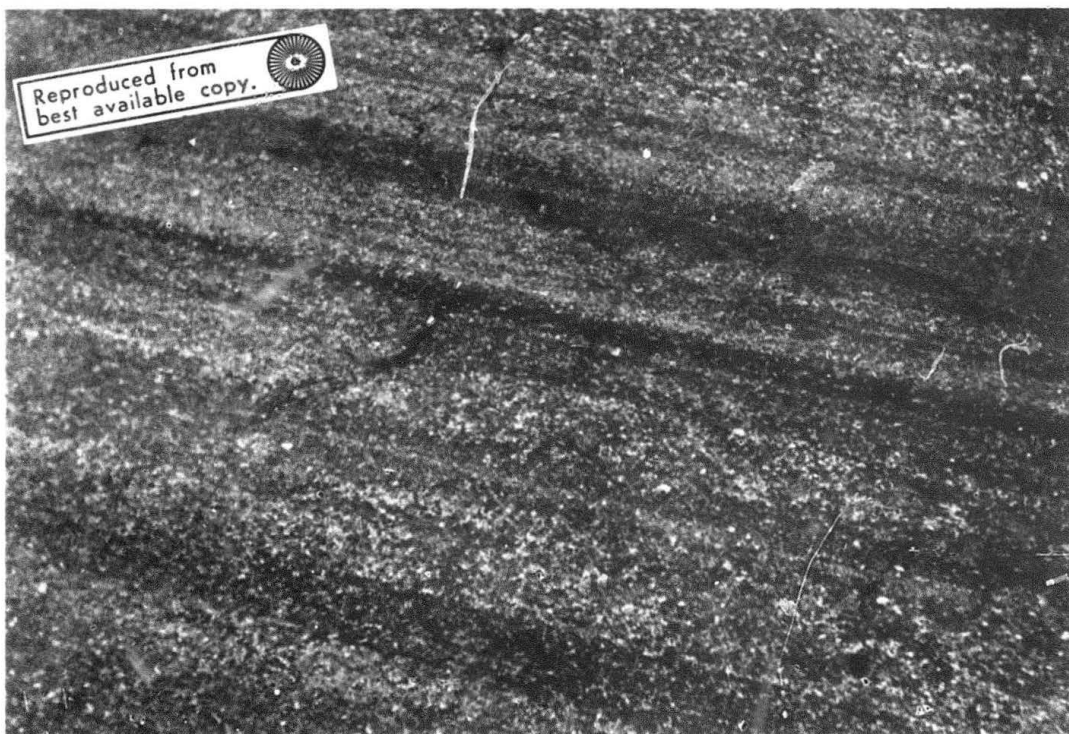
(photograph 3); however, distress in this area was not as severe as that in the area near the middle of the runway.

Photograph 3. Distressed area near north end of runway
